# **8XC196KD COMMERCIAL APPLICATION SPECIFICATION UPDATE**

Release Date: May, 1997  
Order Number: 272833-002

The 8XC196KD may contain design defects or errors known as errata. Characterized errata that may cause the 8XC196KD's behavior to deviate from published specifications are documented in this specification update.

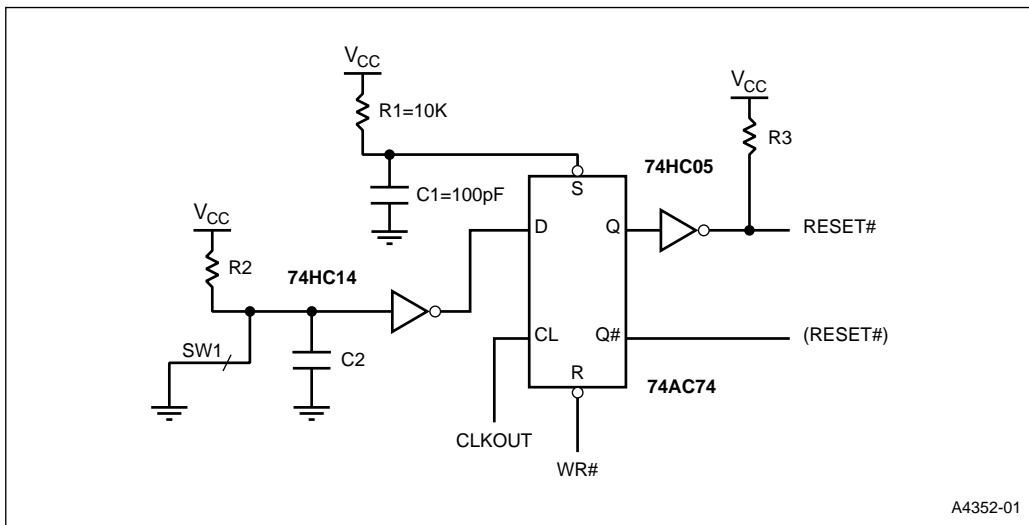
A4352-01

**PROBLEM:** The data bus floats asynchronously with RESET#. If reset occurs during an external write cycle, the contents of the external device may be corrupted. This is the normal operating condition for reset, and is not considered a bug. It is included on this list for those customers that may encounter corruption of data in external RAM during reset.

**IMPLICATION:** Anyone who resets a system while writing to external RAM will be affected. May have to add external circuitry if this is a problem.

**WORKAROUND:** Allow reset to occur only at the rising edge of CLKOUT and only if WR# is high. If a reset occurs during an external bus write cycle, RAM data on the external bus may be corrupted. This describes a logic design that will alleviate the problem.

The following circuit will allow a manual Reset to occur at the rising edge of CLKOUT only if WR# is high (inactive). If WR# is low (active) then RESET# will stay 'high' (inactive). The 74HC14 and 74HC05 are usually already in the system, so the only additional components are the 74AC74, R1, and C1.

1.  $R1 = 10K$  and  $C1 = 100 \text{ pF}$ .
2.  $R2$  and  $C2$  should allow for Reset state times plus write wait states.

The  $R1 \cdot C1$  time constant is one microsecond to ensure that the flip-flop comes up 'on' after a power-up. The reset flip-flop at the rising edge of CLKOUT after the  $R2 \cdot C2$  time constant has expired.

For manual resets, the flip-flop will turn on at the next rising edge of CLKOUT unless WR# is low. If WR# is low, the flip-flop turn on will be delayed until the next rising edge of CLKOUT when WR# is not low. This may occur after any number of wait states. The  $R2 \cdot C2$  time constant must be long enough for the normal reset state times plus the maximum number of write wait states.

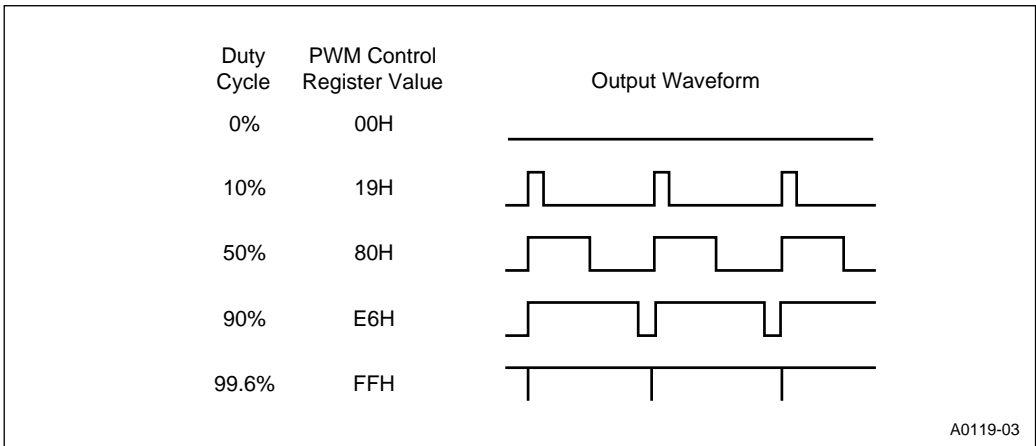
**PROBLEM:** Add the following sentences to the second paragraph after the first sentence: 'Since the value written to the control register is buffered, you can write a new 8-bit value to PWMx\_CONTROL before the counter overflows. The new value is used during the next period of PWMx.'

The following figure replaces Figure 10-2.

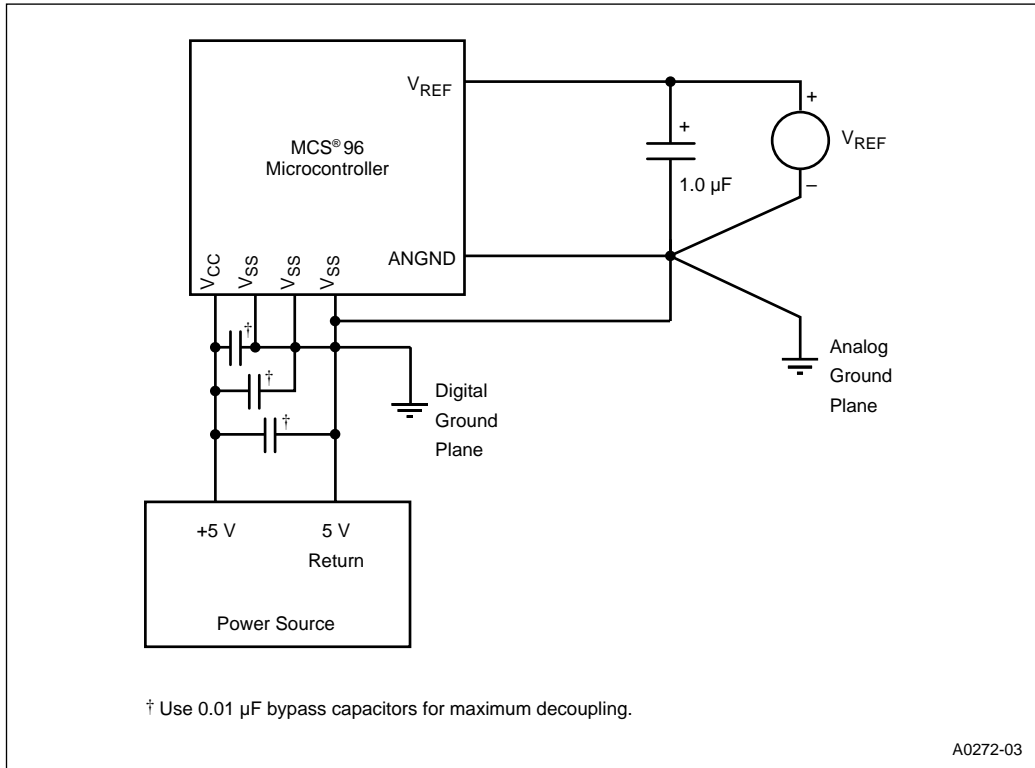
**PROBLEM:** In Figure 11-2, the recommended capacitor value between  $V_{CC}$  and  $V_{SS}$  is  $0.01\ \mu\text{F}$  or greater. Also the recommended capacitor value between  $V_{REF}$  and  $\text{ANGND}$  is  $1.0\ \mu\text{F}$ .

'Connect a  $0.01\text{-}\mu\text{F}$  bypass capacitor between  $V_{CC}$  and each  $V_{SS}$  pin and a  $1.0\text{-}\mu\text{F}$  capacitor between  $V_{REF}$  and  $\text{ANGND}$ .'

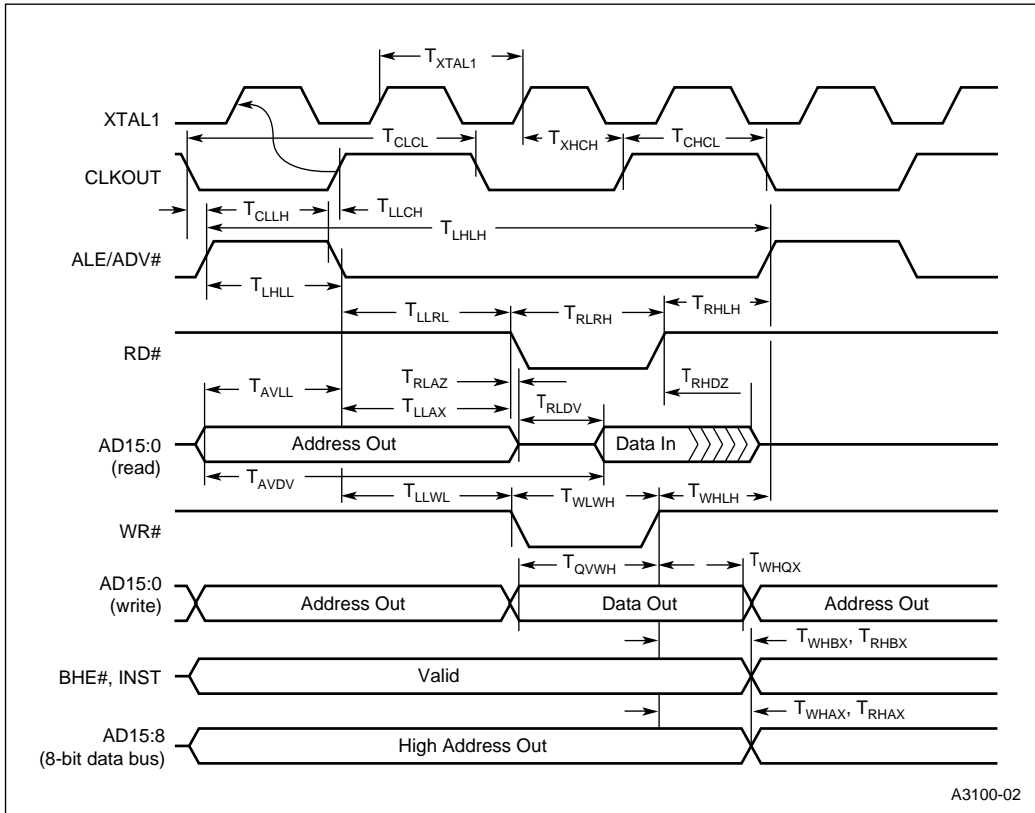
A3100-02

**PROBLEM:** Figure 13-20 displays the system bus timing. However, there are a couple of mistakes. First, the WR# signal shows a range for the transition from high to low. This is incorrect, it should be a single line. Next, the signal labeled BUS should not refer to 16-bit mode only. This BUS signal shows AD0-7 in 8-bit mode and the entire bus (AD0-15) in 16-bit mode. The following figure replaces Figure 13-20.

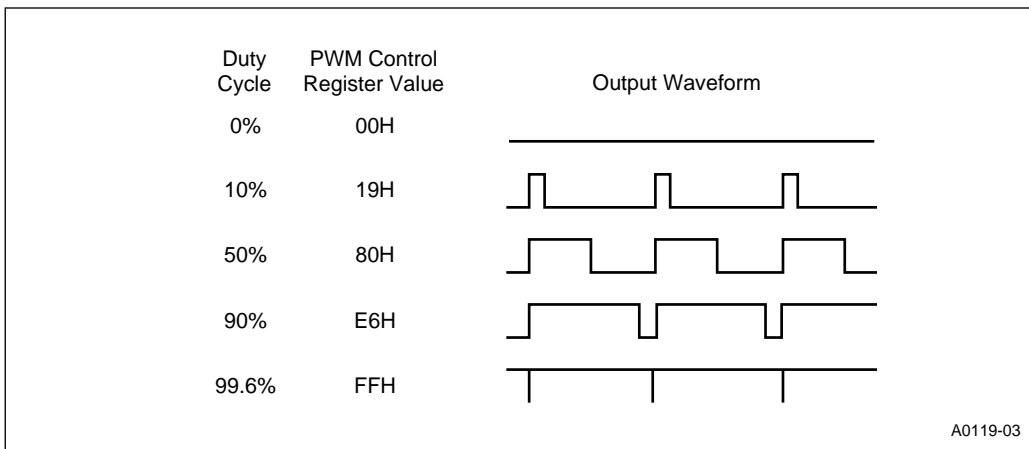
**ITEM:** On page 10-2, add the following sentences to the second paragraph after the first sentence: 'Since the value written to the control register is buffered, you can write a new 8-bit value to PWMx\_CONTROL before the counter overflows. The new value is used during the next period of PWMx.'

The following figure replaces Figure 10-2.

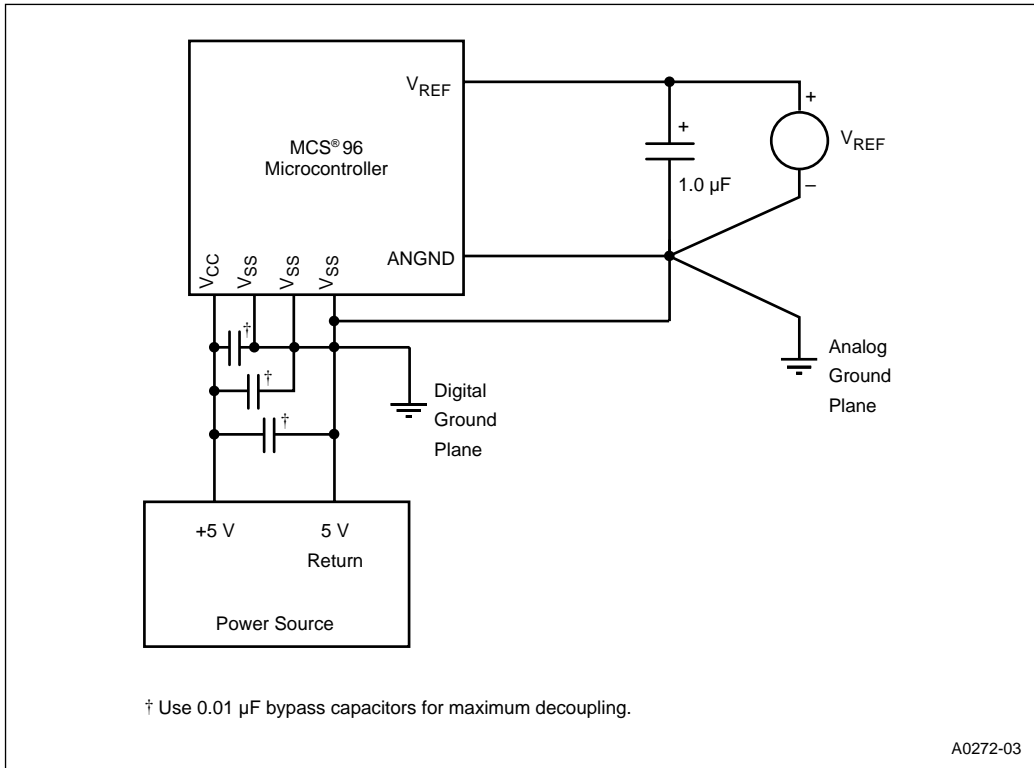
**ITEM:** In Figure 11-2, the recommended capacitor value between  $V_{CC}$  and  $V_{SS}$  is **0.01  $\mu F$**  or greater. Also the recommended capacitor value between  $V_{REF}$  and ANGND is **1.0  $\mu F$** . The following figure replaces Figure 11-2:

‘Connect a 0.01- $\mu\text{F}$  bypass capacitor between  $V_{CC}$  and each  $V_{SS}$  pin and a 1.0- $\mu\text{F}$  capacitor between  $V_{REF}$  and  $ANGND$ .’

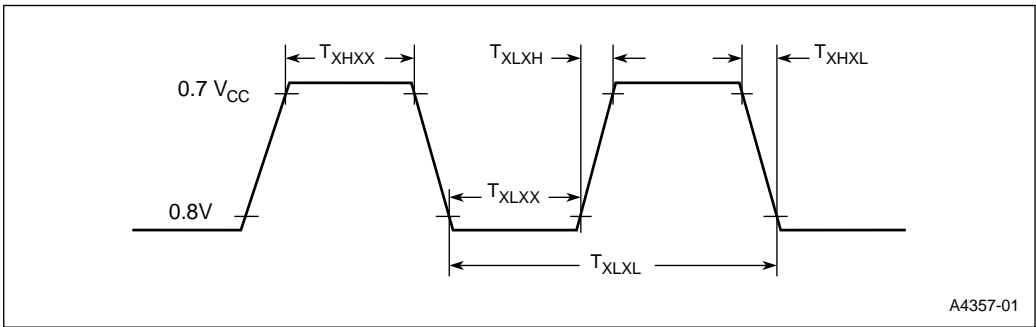
Figure 11-6. External Clock Drive

**ITEM:** In Figure 11-6, the timing diagram incorrectly represents the  $T_{x|xl}$  and  $T_{xhx|}$  timing specifications. The timing diagram below replaces Figure 11-6.

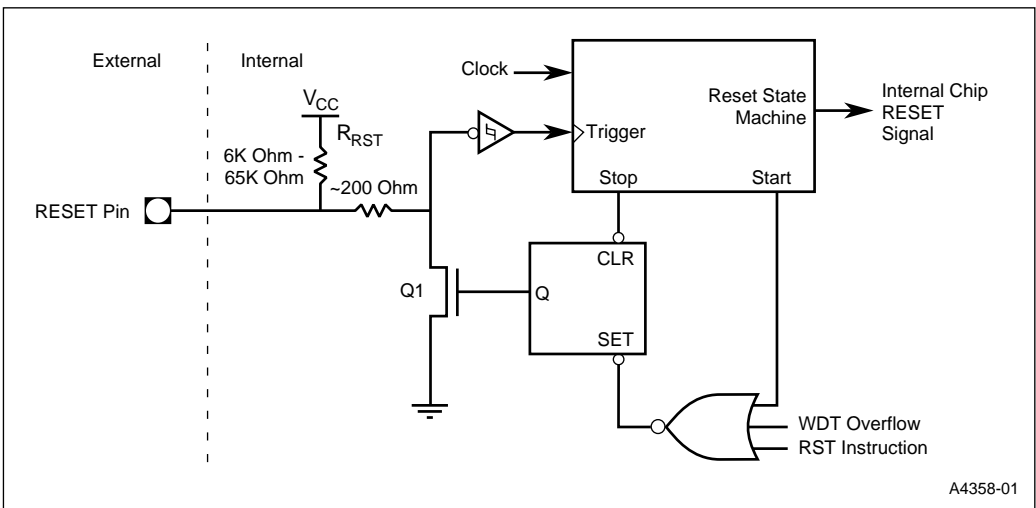
Figure 11-8. Reset Pin Internal Circuit

**ITEM:** Figure 11-8 shows the reset pin internal circuit. However, there are a couple of mistakes; the following figure shows the corrected version. The **inverter** at the Reset State Machines Trigger input and the **OR gate** at the SET input of the latch are the corrections to this figure.
