8XC196KB SPECIFICATION UPDATE

Release Date: December, 1996

Order Number: 272835-002

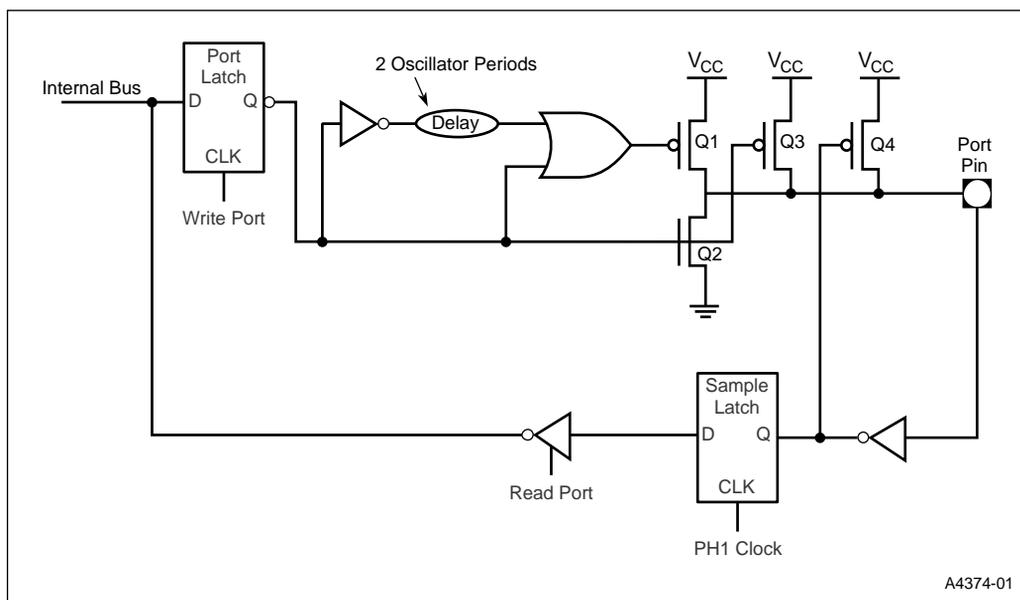
Figure 1. Quasi-bidirectional Port Circuit

PROBLEM: To meet the device characteristics at low temperatures, the specification for I_{TL} on the 8XC198 and 8XC196KB/8XC196KB16 (where X = 0, 3, or 7) devices has changed from -650 μ A to -800 μ A.

The I_{TL} specification is the maximum current that the 8XC196KB quasi-bidirectional pins can source during the transition from a logic 1 to a logic 0 input. Figure 1 shows the quasi-bidirectional port circuit. When the port is configured as an input, the output of the port latch is a '0'. Therefore, Q3 is weakly pulling the port pin high. When the external circuitry drives the pin high, Q4 also is turned on and holds the port pin signal high. As the external circuitry decreases the voltage below V_{CC} toward logic 0, Q4 begins to turn off. However, due to transistor characteristics, Q4 will source increasing amounts of current until the threshold voltage of the transistor is reached. Then Q4 will turn off, leaving only Q3 driving the port pin signal high.

IMPLICATION: Customers using the quasi-bidirectional pins as input should analyze their applications to see if their external circuitry can handle 80 μ A of current from the quasi-bidirectional pins during the transition period explained above.

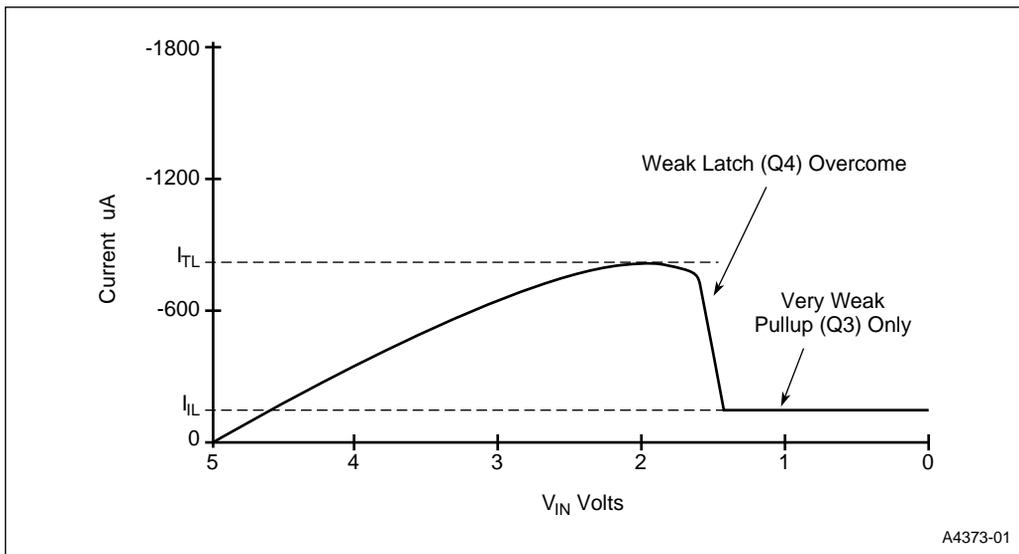
Figure 2. Quasi-bidirectional Port DC Characteristics (“1” Written to Port Pin)

Figure 2 shows the transfer characteristic of the port pin during the input's transition from logic 1 to logic 0. The I_{IL} specification shows the amount of current Q3 will source after Q4 turns off. The I_{TL} specification gives the maximum amount of current that Q4 will source during the input's transition from logic 1 to logic 0.

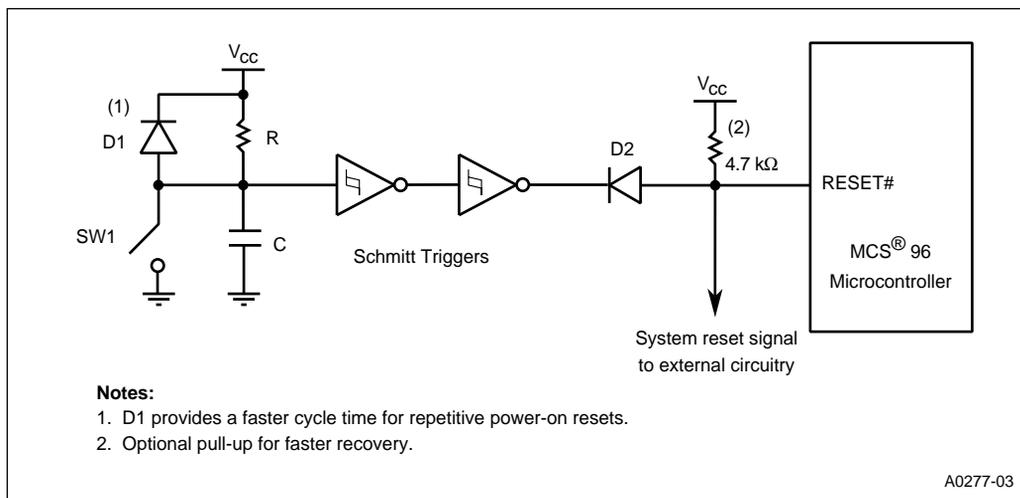
Figure 3. Improved System Reset Circuit

PROBLEM: The following improved system reset circuit shown in Figure 3 may be used in conjunction with the *80C196KB User's Guide (270651-003)*.

The system reset circuit in the *80C196KB User's Guide* has been used successfully by many customers for a long period of time. Both circuits should be evaluated in the user's system.
