# **87C196KQ SPECIFICATION UPDATE**

Release Date: January, 1997

Order Number: 272837-002

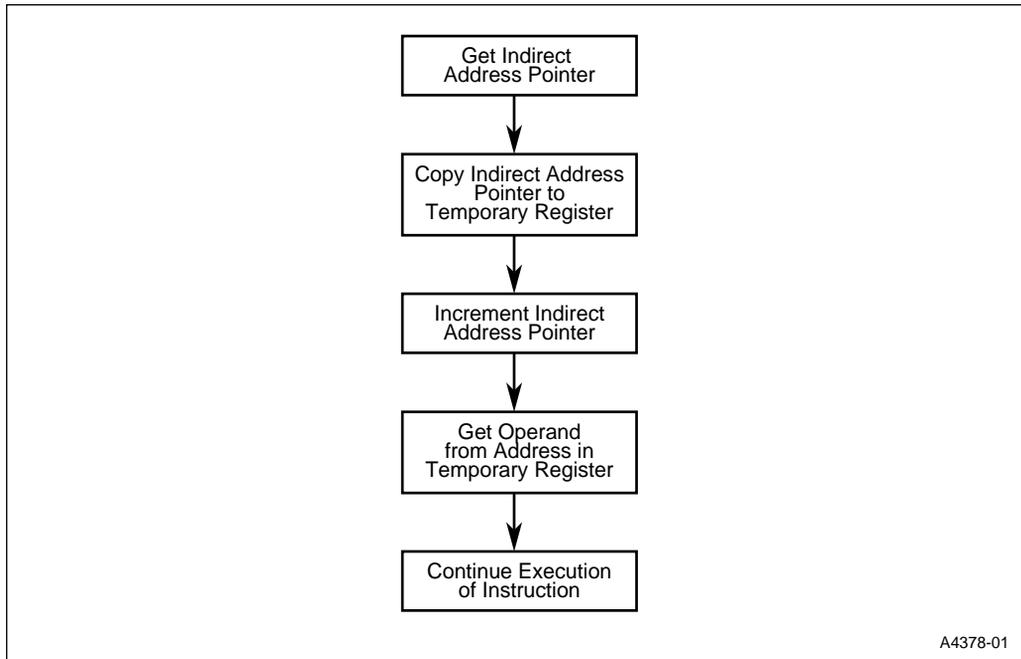
**PROBLEM:** For indirect addressing with autoincrement, a pointer that points to itself results in an access to the incremented pointer address rather than the original pointer address.

The CPU stores the pointer's value in a temporary register, increments the pointer, then accesses the operand at the address contained in the temporary register, as shown in this flowchart.

Therefore, if the pointer points to itself, the CPU accesses the operand at the incremented address contained in the pointer.

**WORKAROUND:** Avoid using an indirect address pointer that points to itself. For example, assume ax = 1CH, bx = 1DH, and cx = 40H. The following code causes the CPU to access the operand at the intended, unincremented address:

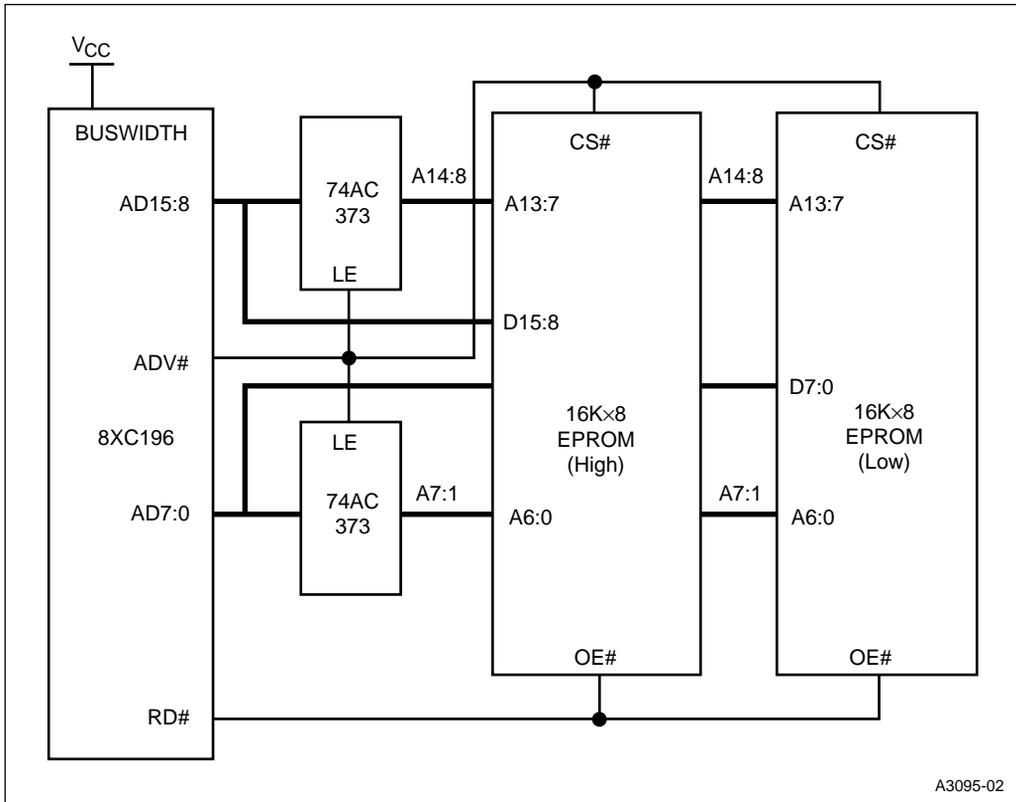
Figure 1. 16-bit System with EPROM

- 001.**        *High address inputs to the low EPROM should be A14:8 in Figure 15-18.*

**ITEM:** The next revision of the user's manual will include the following corrected graphic.
