# 8XC196KD AUTOMOTIVE APPLICATION SPECIFICATION UPDATE

Release Date: May, 1998  
Order Number: 272839-003

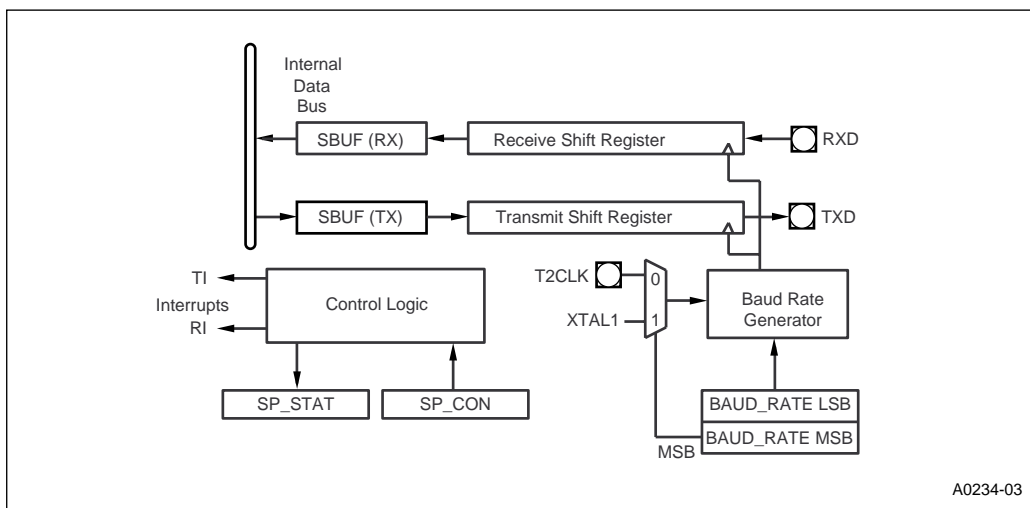
Serial Port Block Diagram

**ITEM:** The following block diagram will be included in future manuals.

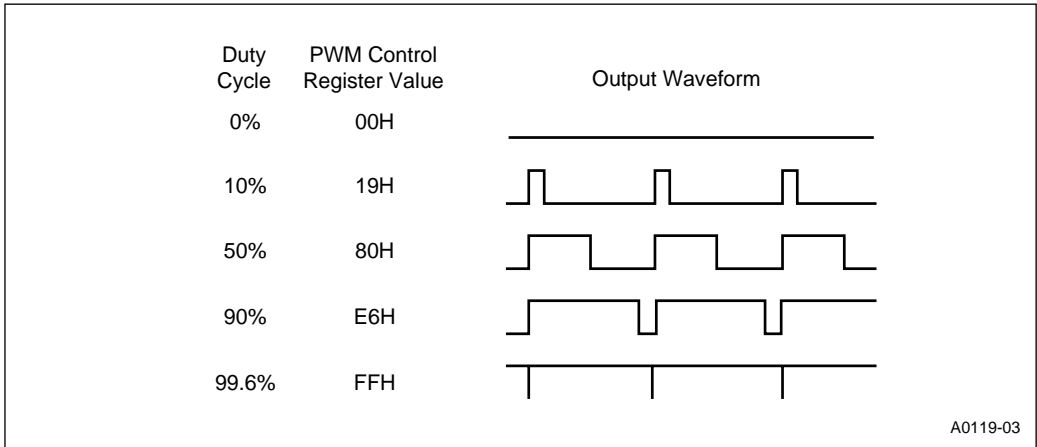
**ITEM:** On page 10-2, add the following sentences to the second paragraph after the first sentence: ‘Since the value written to the control register is buffered, you can write a new 8-bit value to PWMx\_CONTROL before the counter overflows. The new value is used during the next period of PWMx.’

The following figure replaces Figure 10-2:

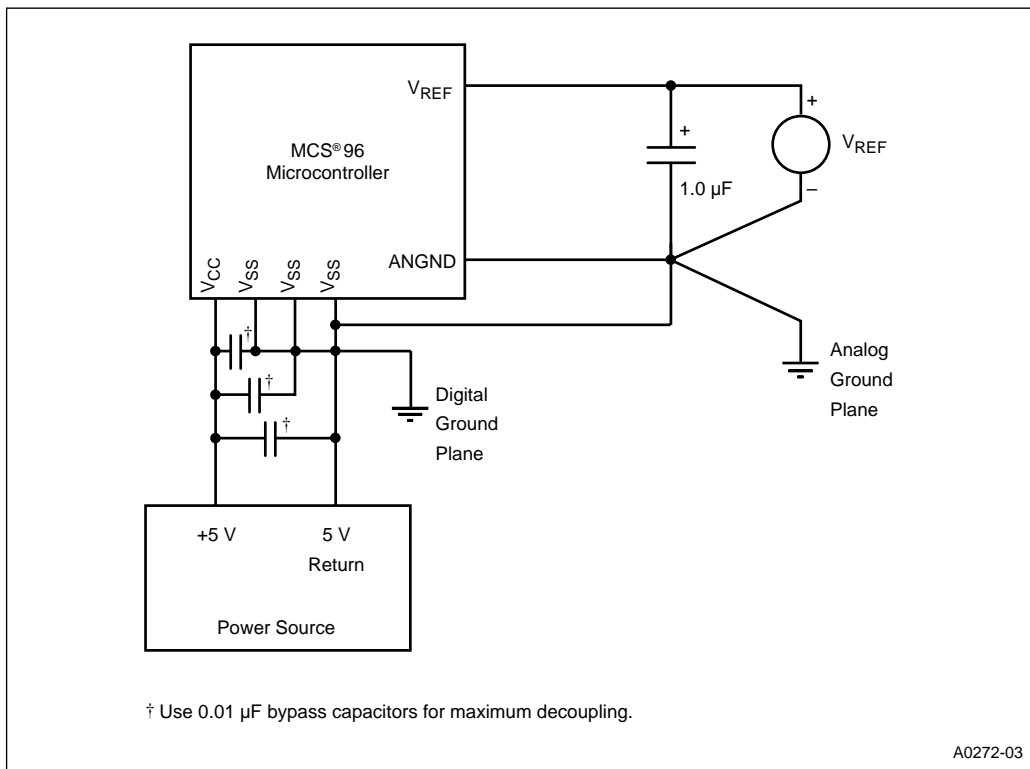
**ITEM:** In Figure 11-2, the recommended capacitor value between  $V_{CC}$  and  $V_{SS}$  is **0.01  $\mu F$**  or greater. Also the recommended capacitor value between  $V_{REF}$  and  $ANGND$  is **1.0  $\mu F$** . The following figure replaces Figure 11-2:

In Section 11.2.1, the reason for these capacitors is explained. However, the second to last line of the first paragraph should read as follows:

‘Connect a 0.01- $\mu\text{F}$  bypass capacitor between  $V_{CC}$  and each  $V_{SS}$  pin and a 1.0- $\mu\text{F}$  capacitor between  $V_{REF}$  and  $ANGND$ .’

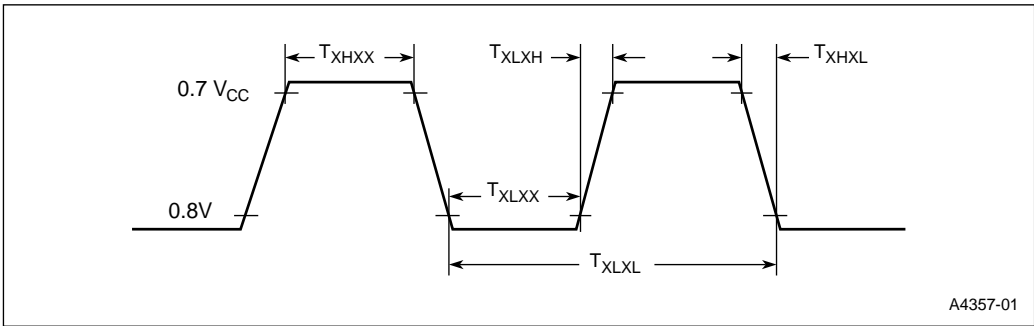
Figure 11-6. External Clock Drive

**ITEM:** In Figure 11-6, the timing diagram incorrectly represents the  $T_{x|xl}$  and  $T_{x|xl}$  timing specifications. The timing diagram below replaces Figure 11-6.

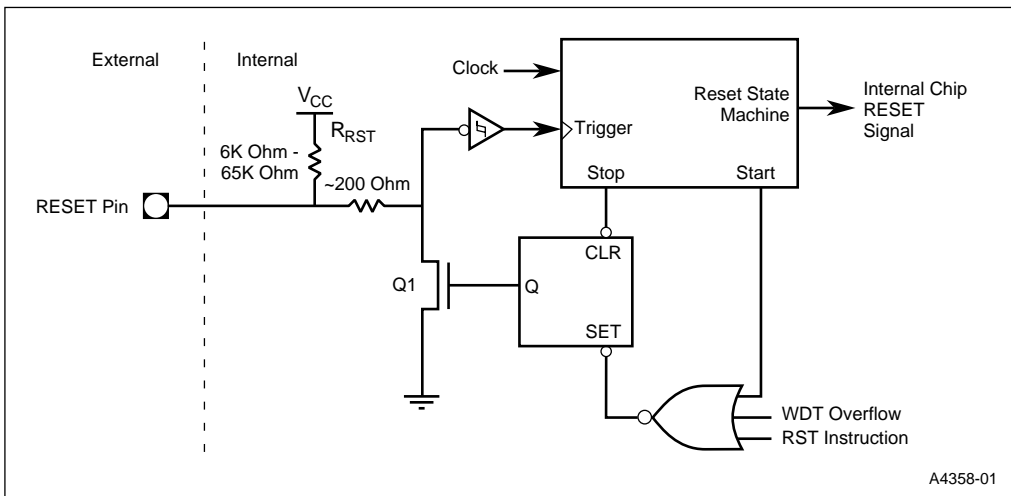
Figure 11-8. Reset Pin Internal Circuit

**ITEM:** Figure 11-8 shows the reset pin internal circuit. However, there are a couple of mistakes; the following figure shows the corrected version. The **inverter** at the Reset State Machines Trigger input and the **OR gate** at the SET input of the latch are the corrections to this figure.
