87C196KT Microcontroller

Specification Update

November, 1998

Order Number: [272862-004](#)

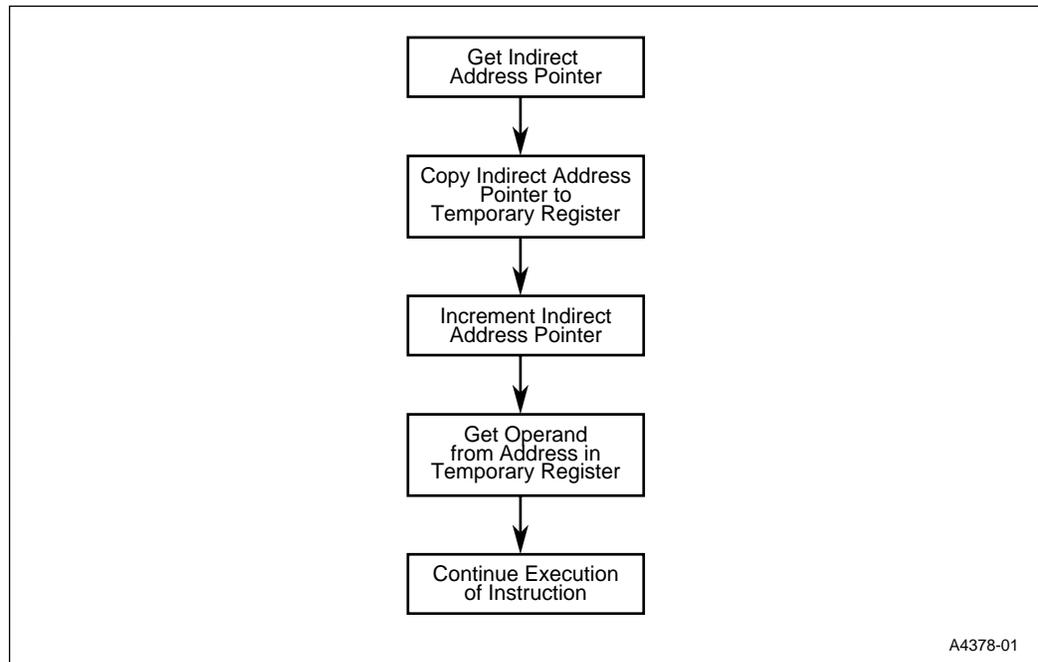
Problem: For indirect addressing with autoincrement, a pointer that points to itself results in an access to the incremented pointer address rather than the original pointer address.

The CPU stores the pointer's value in a temporary register, increments the pointer, then accesses the operand at the address contained in the temporary register, as shown in the following flowchart.

Therefore, if the pointer points to itself, the CPU accesses the operand at the incremented address contained in the pointer.

Workaround: Avoid using an indirect address pointer that points to itself.

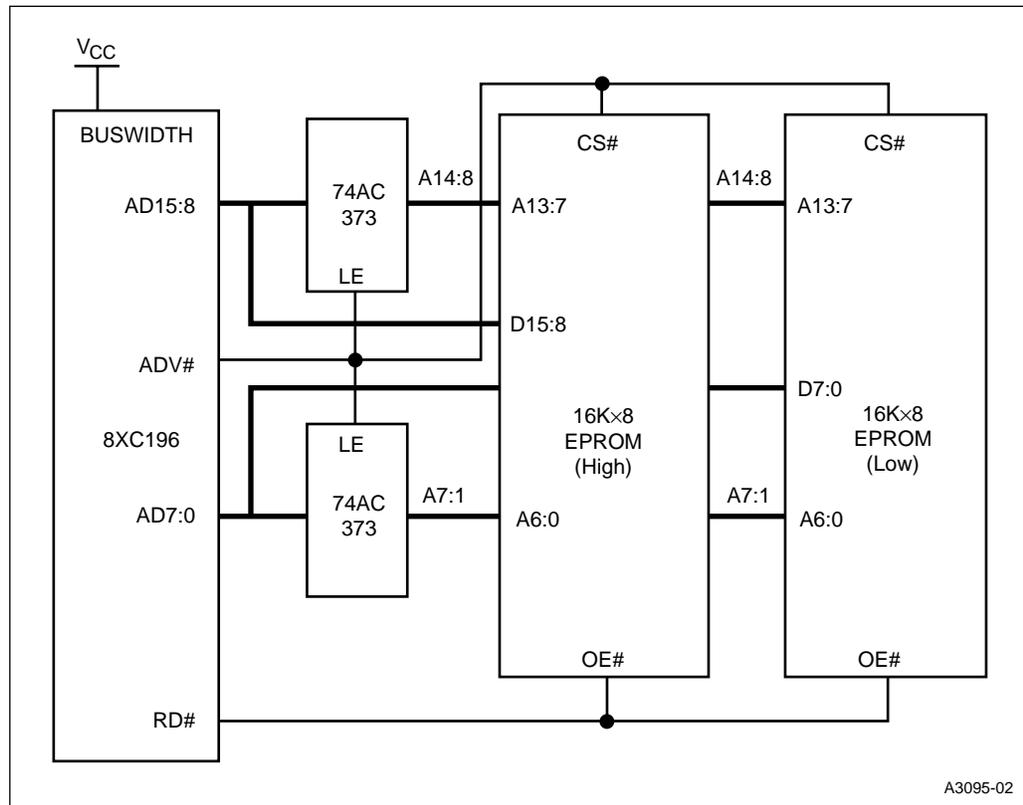
Figure 1. 16-bit System with EPROM

Issue: In the *87C196Kx, 8XC196Jx, 87C196CA Microcontroller Family User's Manual*, the block diagram for a 16-bit system with EPROM incorrectly listed the high address inputs to the low EPROM as A15:8. The correct inputs are A14:8, as reflected in the following figure:
