# 87C196KT 20 MHz–Automotive

Specification Update

*November 1998*

Order Number: [272863-004](#)

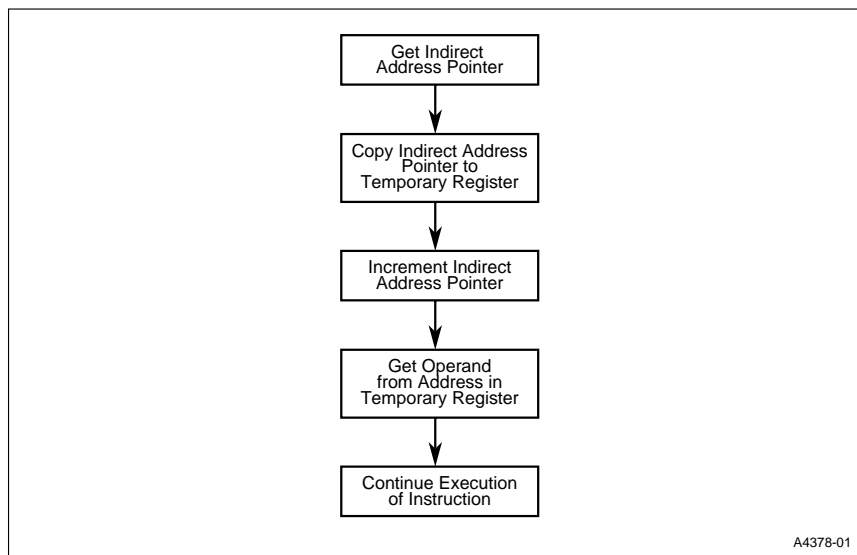
**Problem:** For indirect addressing with autoincrement, a pointer that points to itself results in an access to the incremented pointer address rather than the original pointer address.

The CPU stores the pointer's value in a temporary register, increments the pointer, then accesses the operand at the address contained in the temporary register, as shown in this flowchart.

Therefore, if the pointer points to itself, the CPU accesses the operand at the incremented address contained in the pointer.

**Workaround:** Avoid using an indirect address pointer that points to itself.

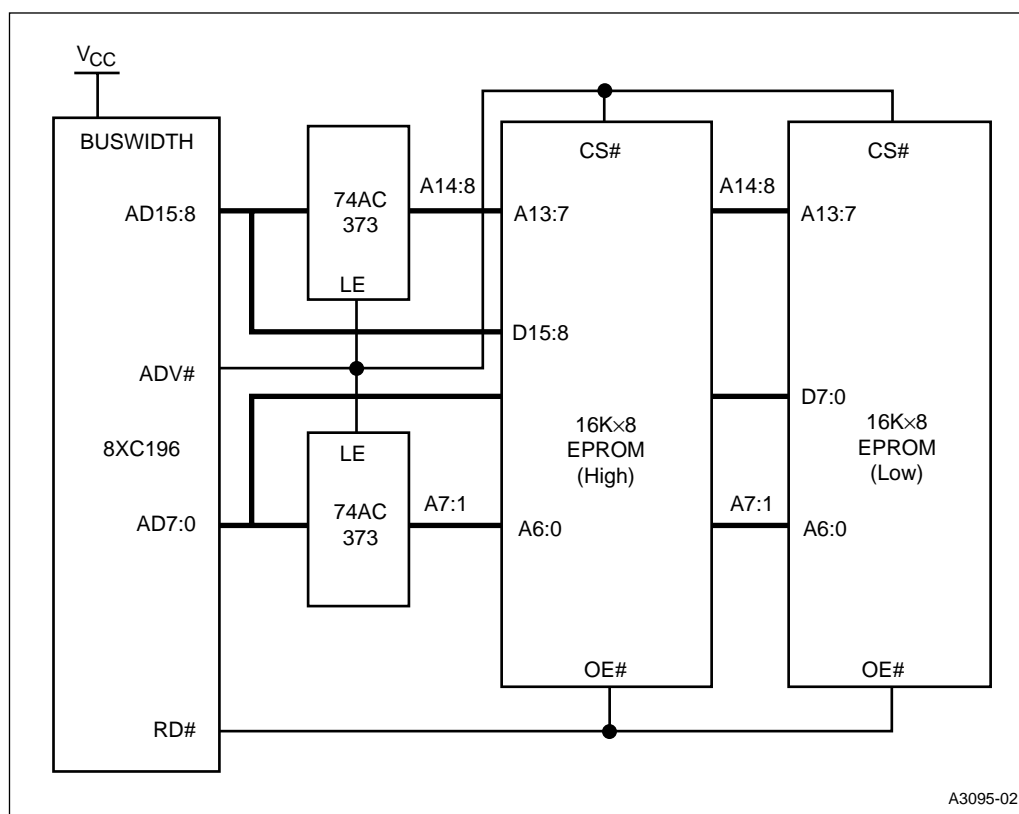
**Figure 1. 16-bit System with EPROM**

**Issue:** In the *87C196Kx, 8XC196Jx, 87C196CA Microcontroller Family User's Manual*, the block diagram for a 16-bit system with EPROM incorrectly listed the high address inputs to the low EPROM as A15:8. The correct inputs are A14:8, as reflected in the following figure:
