80296SA MICROCONTROLLER SPECIFICATION UPDATE

Release Date: February, 1997

Order Number: 272908-006

The 80296SA may contain design defects or errors known as errata. Characterized errata that may cause the 80296SA's behavior to deviate from published specifications are documented in this specification update.

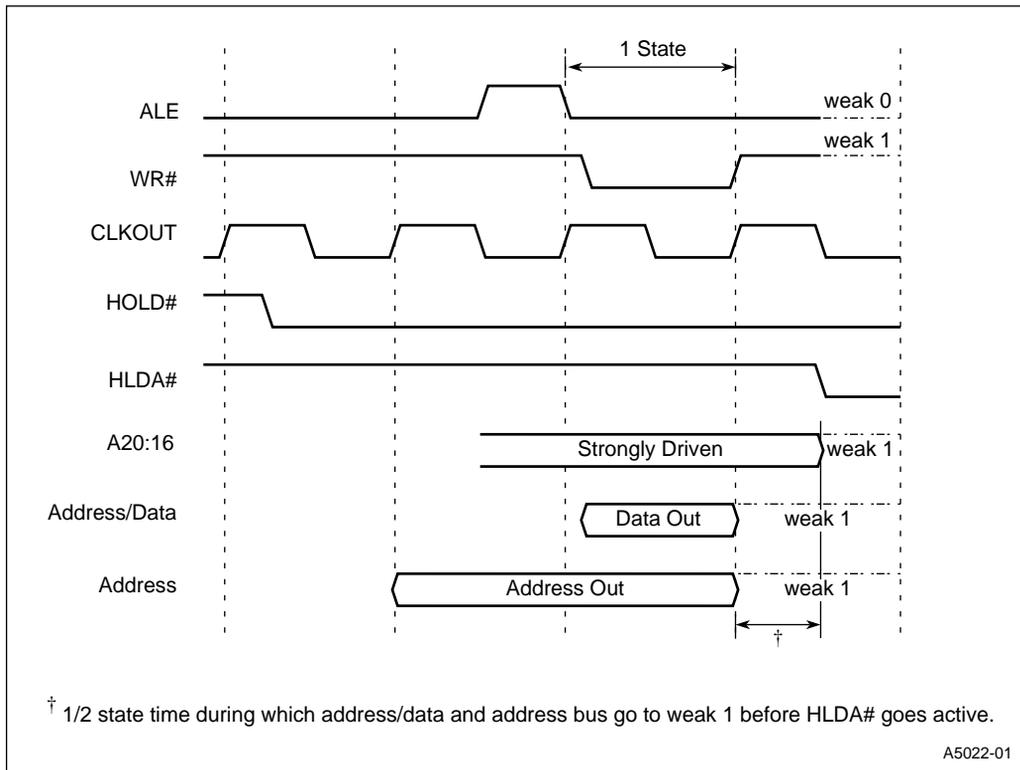
Behavior of Bus Signals When Entering Bus Hold

PROBLEM: When going into bus hold, the address/data bus and address bus pins go to their hold values about 1/2 state early before HLDA# goes low. The other bus signals, such as the EPORT, ALE, RD#, WR#, etc., remain strongly driven for about 1/2 state longer until HLDA# goes active. Please refer to the diagram:

IMPLICATION: In the figure above, a write cycle is occurring just before the 80296SA releases the bus and goes into hold mode. This write cycle cannot be relied upon, since the 80296SA stops driving valid information on the address and address/data bus at nearly the same time as WR# goes high. The address behaves the same as in normal bus cycles. The data is held longer, though, in the normal bus cycle.

This may make bus hold unreliable and unusable.

WORKAROUND: There is no workaround unless the device receiving data does not expect the data to be held after rising edge of WR#.

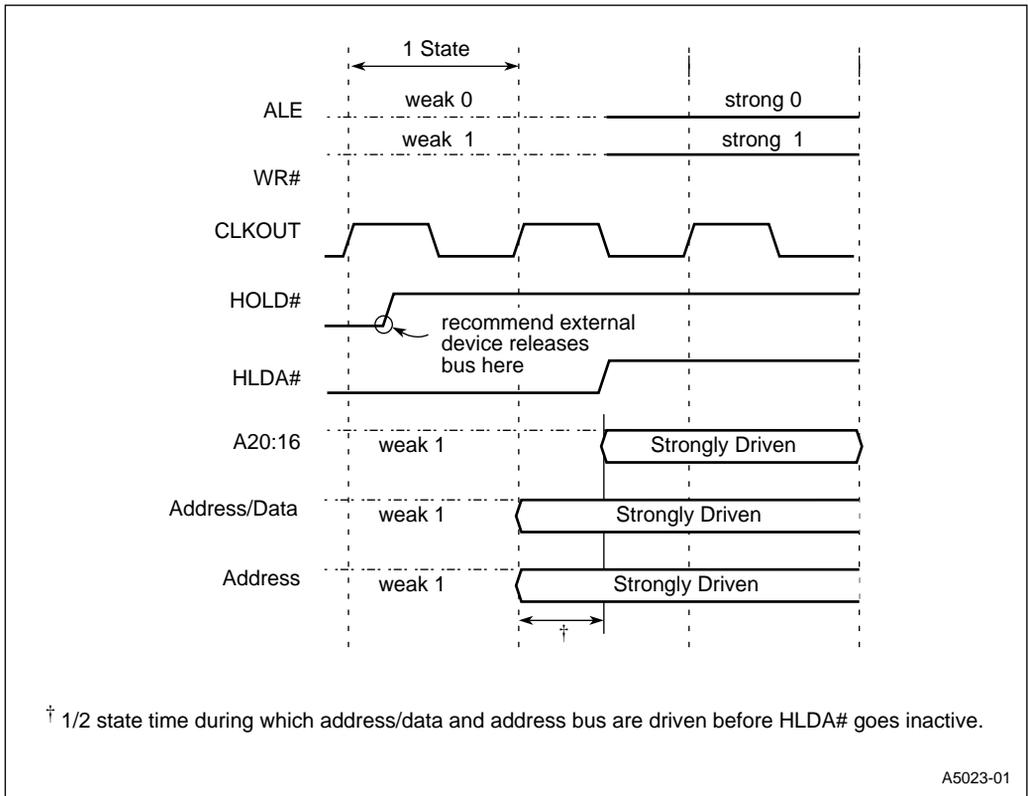
Behavior Of Bus Signals When Exiting Bus Hold

PROBLEM: When coming out of bus hold, the 80296SA starts to strongly drive the address/data and address bus pins about 1/2 state early before HLDA# goes inactive. The other bus signals such as EPORT, ALE, RD#, WR#, etc. start being driven about the same time as HLDA# gets released, but the address/data and address bus start being driven about 1/2 state before HLDA# gets released. Please refer to the diagram:

IMPLICATION: There may be contention on the address/data and address bus, but this is not likely, since HOLD# has already been released.

WORKAROUND: If the external device releases the bus when HOLD# goes inactive, the signals driven before HLDA# goes inactive are not an issue and should not cause bus contention. It is recommended that HOLD# be used as the signal to inform devices to release the bus.

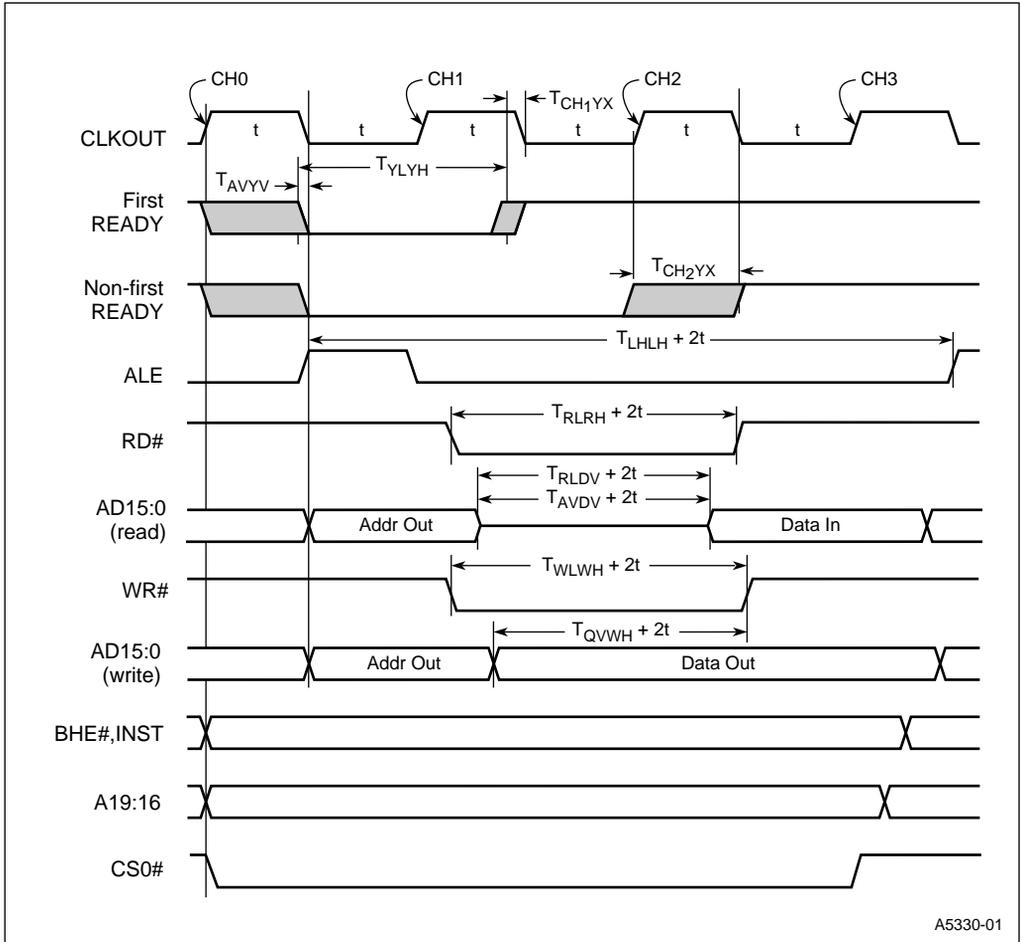
Example READY Timings at 50 MHz, Multiplexed Bus, BUSCONx = 1 Wait State

ITEM: The T_{CHYX} specification has been replaced by two specifications, T_{CH1YX} and T_{CH2YX} , to more clearly define the timing requirements for the first READY pulse and for subsequent READY pulses.

1. If using the READY signal to insert wait states, you must program at least one wait state in the BUSCONx register because the first falling edge of READY is not synchronized with a CLKOUT edge.
2. If using the BUSCONx register **without** the READY signal to insert wait states, add $2t \times n$, where n = number of wait states.
3. If using the BUSCONx register to insert wait states, add $2t \times (n-1)$, where n = number of wait states.
4. Exceeding the maximum specification causes additional wait states.
5. If you program two or more wait states in the BUSCONx register, the T_{CH1YX} minimum does not apply.

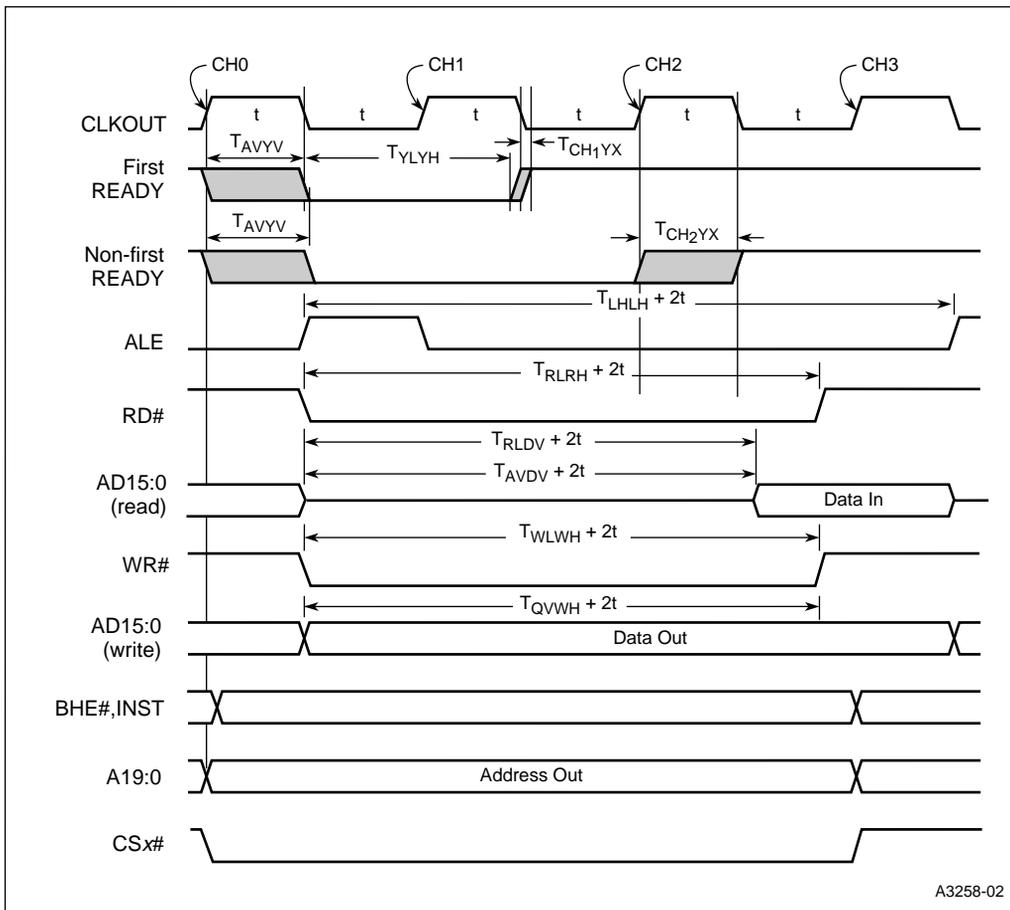
Example READY Timings at 50 MHz, Demultiplexed Bus, BUSCONx = 1 Wait State

1. If using the READY signal to insert wait states, you must program at least one wait state in the BUSCONx register because the first falling edge of READY is not synchronized with a CLKOUT edge.
2. If using the BUSCONx register **without** the READY signal to insert wait states, add $2t \times n$, where n = number of wait states.
3. If CSx# changes or if a write cycle follows a read cycle, add $2t$ (1 state).
4. If using the BUSCONx register to insert wait states, add $2t \times (n-1)$, where n = number of wait states.
5. Exceeding the maximum specification causes additional wait states.
6. If you program two or more wait states in the BUSCONx register, the T_{CH1YX} minimum does not apply.

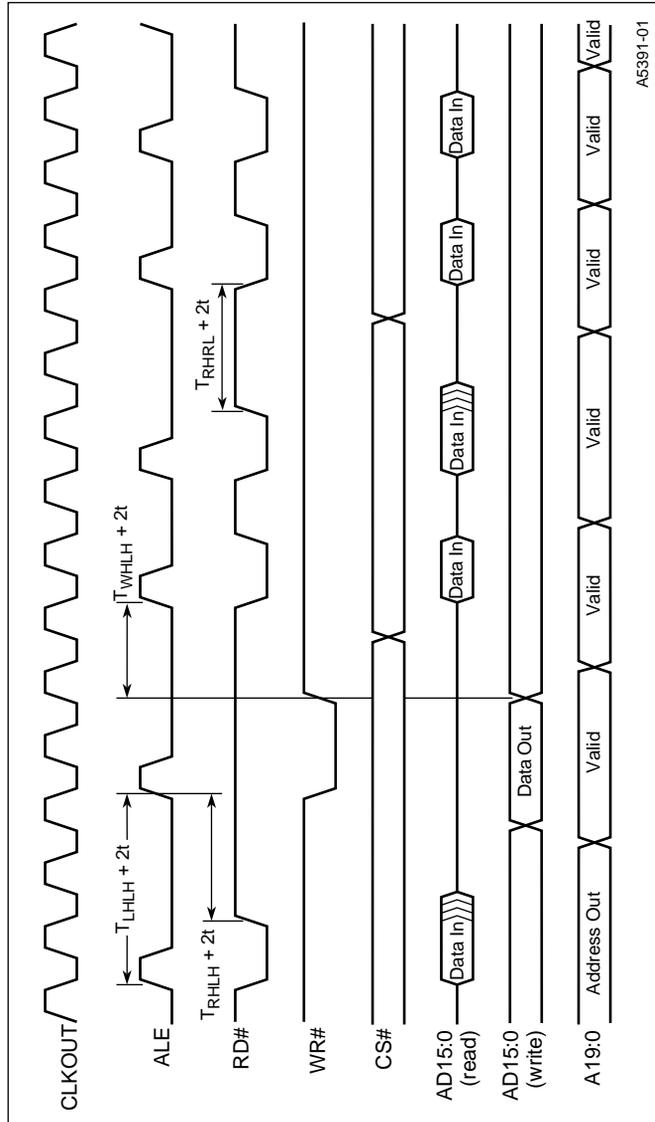
ITEM: In the 80296SA datasheet, first paragraph, the third sentence states, "In the deferred mode, a delay of the WR# signal and the next bus cycle will occur in the first bus cycle following a chip select change and in the first write cycle following a read cycle." It should state, "Delayed bus cycles cause a 2t delay in the last read bus cycle that occurs prior to a write cycle. A 2t delay will also occur in the last read or write cycle prior to a chip select change." Refer to the following deferred bus cycle diagram.
