8XC196KB AUTOMOTIVE APPLICATION SPECIFICATION UPDATE

Release Date: November, 1996

Order Number: 272970-001

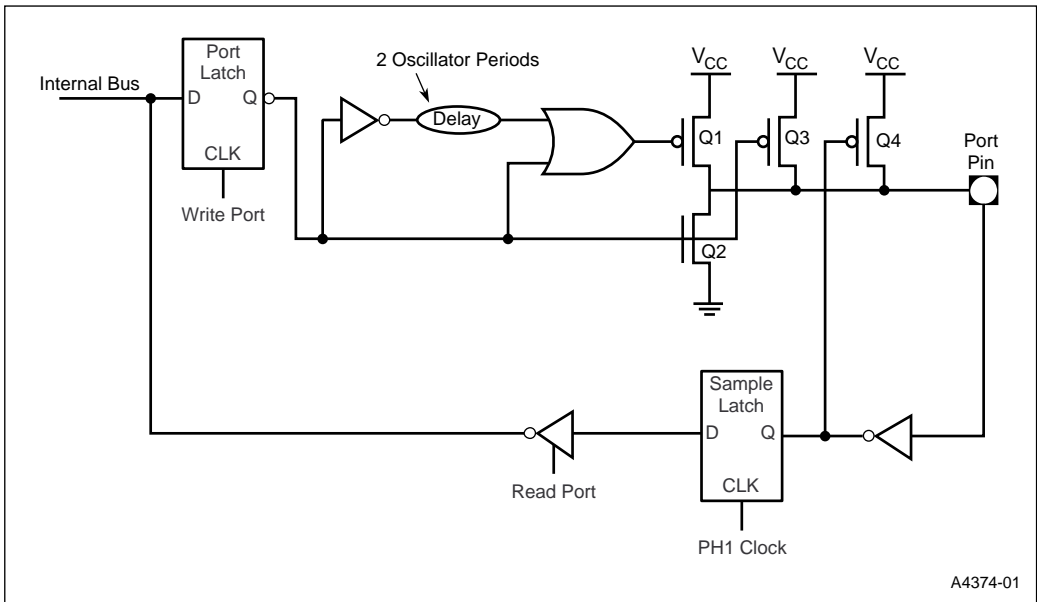
Figure 1. Quasi-bidirectional Port Circuit

PROBLEM: The specification for I_{TL} on the 8XC198 and 8XC196KB/8XC196KB16 devices has changed from -650 μA to -800 μA to meet the device characteristics at low temperatures.

The I_{TL} specification is the maximum current that the 8XC196KB quasi-bidirectional pins can source during the transition from a logic 1 to a logic 0 input. Figure 1 shows the quasi-bidirectional port circuit. When the port is configured as an input, the output of the port latch is a '0'. Therefore, Q3 is weakly pulling the port pin high. When the external circuitry drives the pin high, Q4 also is turned on and holds the port pin signal high. As the external circuitry decreases the voltage below V_{CC} toward logic 0, Q4 begins to turn off. However, due to transistor characteristics, Q4 will source increasing amounts of current until the threshold voltage of the transistor is reached. Then, Q4 will turn off, leaving only Q3 driving the port pin signal high.

IMPLICATION: Customers using the quasi-bidirectional pins as input should analyze their applications to see if their external circuitry can handle 80 μ A of current from the quasi-bidirectional pins during the transition period described above.

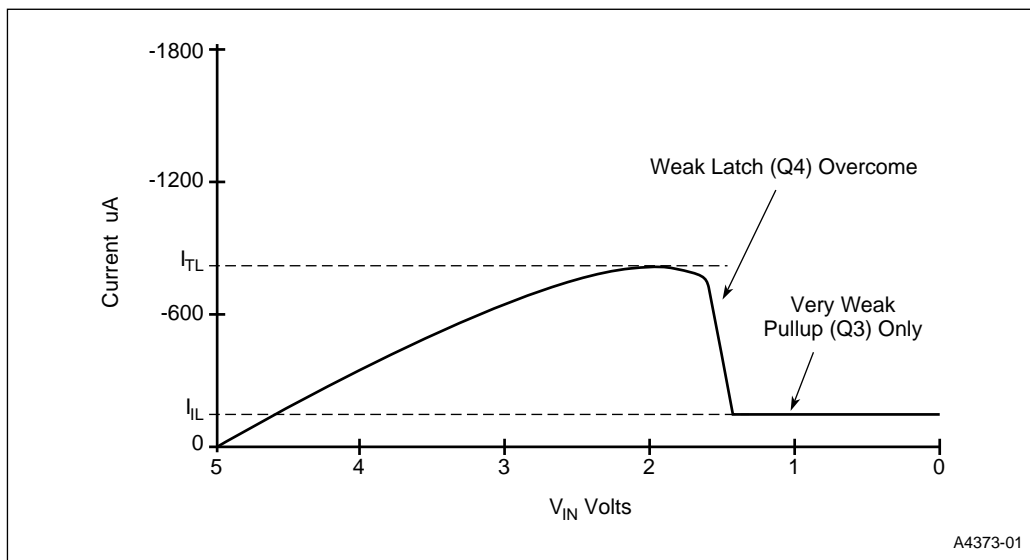
Figure 2. Quasi-bidirectional Port DC Characteristics ("1" Written to Port Pin)

Figure 2 shows the transfer characteristic of the port pin during the input's transition from logic 1 to logic 0. The I_{IL} specification shows the amount of current Q3 will source after Q4 turns off. The I_{TL} specification gives the maximum amount of current that Q4 will source during the input's transition from logic 1 to logic 0.

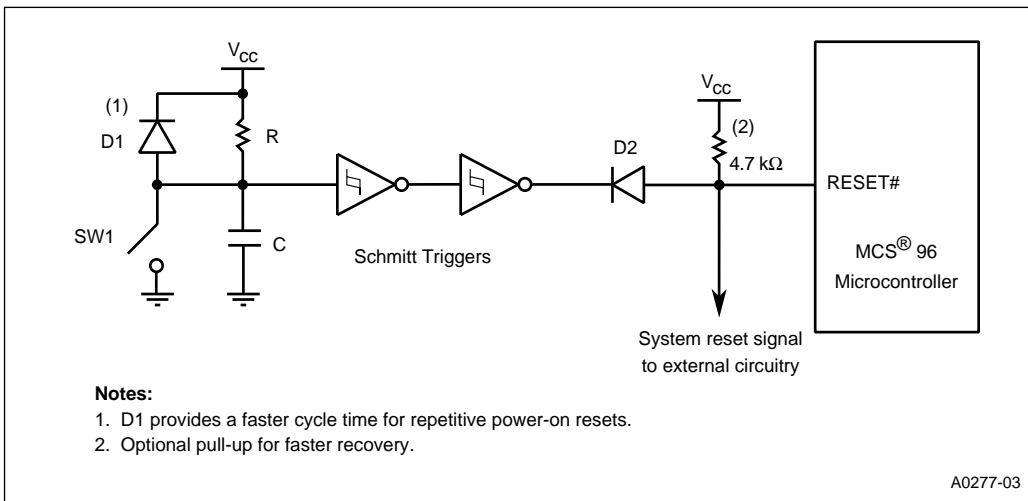
Figure 3. Improved System Reset Circuit

PROBLEM: The following improved system reset circuit shown in Figure 3 may be used in conjunction with the *80C196KB User's Guide* (270651-003).

The system reset circuit in the *80C196KB User's Guide* has been used successfully by many customers for a long period of time. Both circuits should be evaluated in the user's system.
