i960[®] VH Embedded-PCI Processor

Specification Update

November 1998

Order Number: **273174-002**

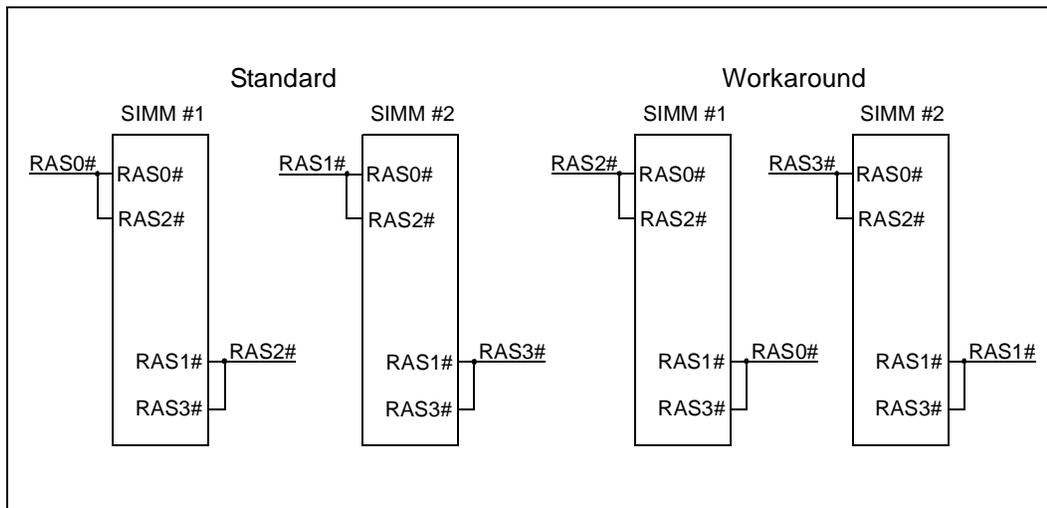
Figure 1. DRAM RAS# Configurations

Problem: The 80960VH MCU supports from one to four banks of DRAM. When the memory subsystem contains fewer than the maximum number of banks used in the 80960VH design, certain addresses may cause the MCU to assert a RAS# to an empty bank. [Table 1](#) shows the relationship between the 80960 local memory address and the RAS# asserted by the MCU.

Implication: The MCU may assert RAS# to access a nonexistent 80960VH DRAM bank. This may occur when the number of DRAM banks installed is less than the maximum number of DRAM banks used in the 80960VH design. Two examples of when this problem can occur are:

When the 80960VH initializes from 80960 local memory instead of FLASH/ROM, the 80960VH's first instruction fetch of the IBR is hard-coded to address 0xFEFF FF30. When the MCU reads this address, it asserts RAS2# or RAS3#, depending on the DRAM bank/leaf size.

CASE 2 WORKAROUND - Initializing from 80960VH DRAM instead of FLASH/ROM

In a standard DRAM configuration, RAS0# and RAS1# are routed to the front sides of the SIMMs, and RAS2# and RAS3# are routed to the back sides of the SIMMs. To implement this workaround, swap RAS0# and RAS2# and swap RAS1# and RAS3#. This routes RAS2# and RAS3# to the front sides of their respective SIMMs, and routes RAS0# and RAS1# to the back sides of their respective SIMMs (See [Figure 1](#)). To determine which RAS# is asserted for a particular address and DRAM configuration, see [Table 1](#).

When initializing from 80960VH DRAM, the first instruction fetch of the IBR is hard-coded to address 0xFEFF FF30; as a result, A23:22 = 11₂ and RAS3# is asserted. With the workaround in place, the RAS# lines are swapped and RAS3# is connected to the front side of the second SIMM and the IBR can be read.
