# 87C196JT Specification Update

Automotive

*December 1998*

Order Number: **273220-001**

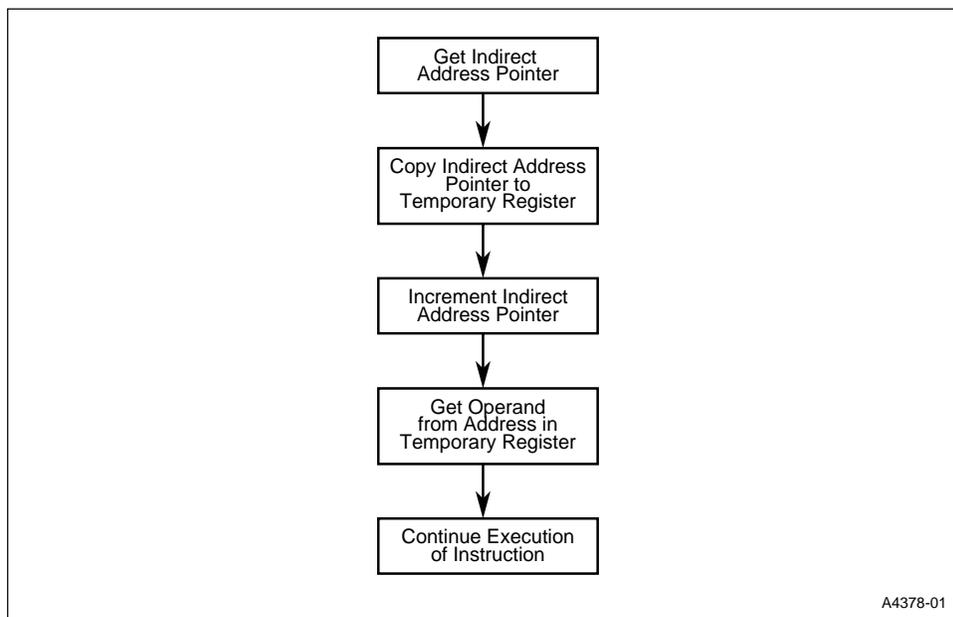
**Problem:** For indirect addressing with autoincrement, a pointer that points to itself results in an access to the incremented pointer address rather than the original pointer address.

The CPU stores the pointer's value in a temporary register, increments the pointer, then accesses the operand at the address contained in the temporary register, as shown in this flowchart.

Therefore, if the pointer points to itself, the CPU accesses the operand at the incremented address contained in the pointer.

**Workaround:** Avoid using an indirect address pointer that points to itself.

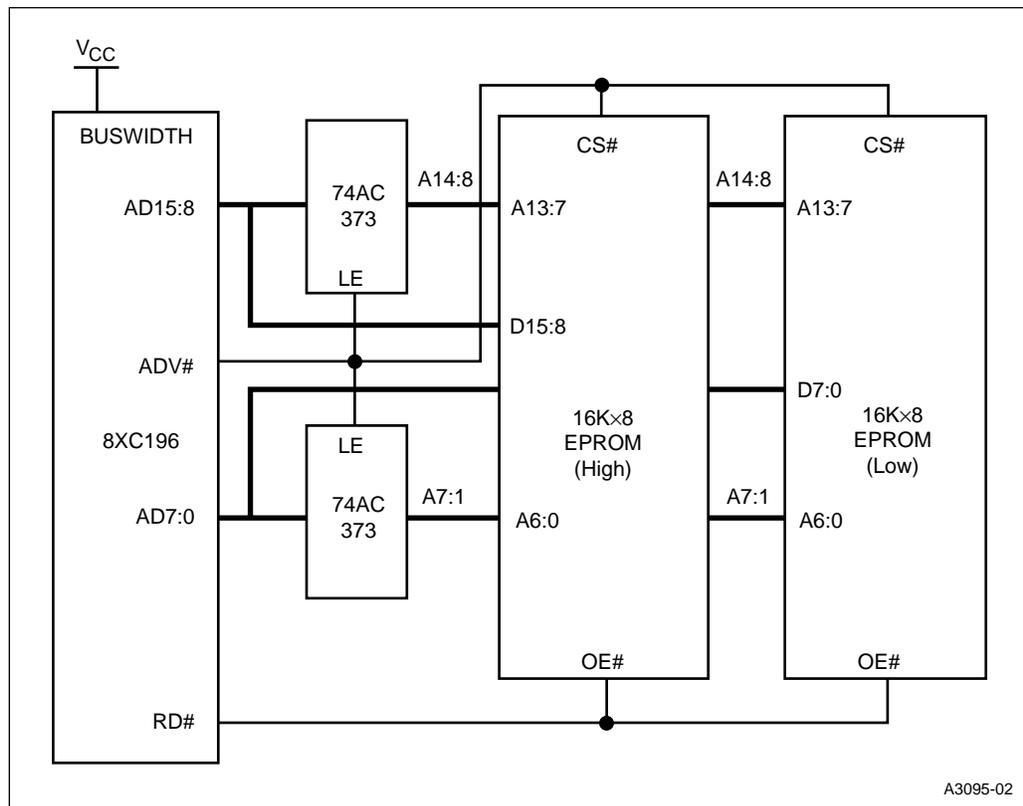
**Figure 1. 16-bit System with EPROM**

**1. High address inputs to the low EPROM should be A14:8 in Figure 15-18**

**Issue:** The next revision of the user’s manual will include the following corrected graphic.
