# **8XC196KD COMMERCIAL APPLICATION SPECIFICATION UPDATE**

Release Date: May, 1997  
Order Number: 272833-002

The 8XC196KD may contain design defects or errors known as errata. Characterized errata that may cause the 8XC196KD's behavior to deviate from published specifications are documented in this specification update.

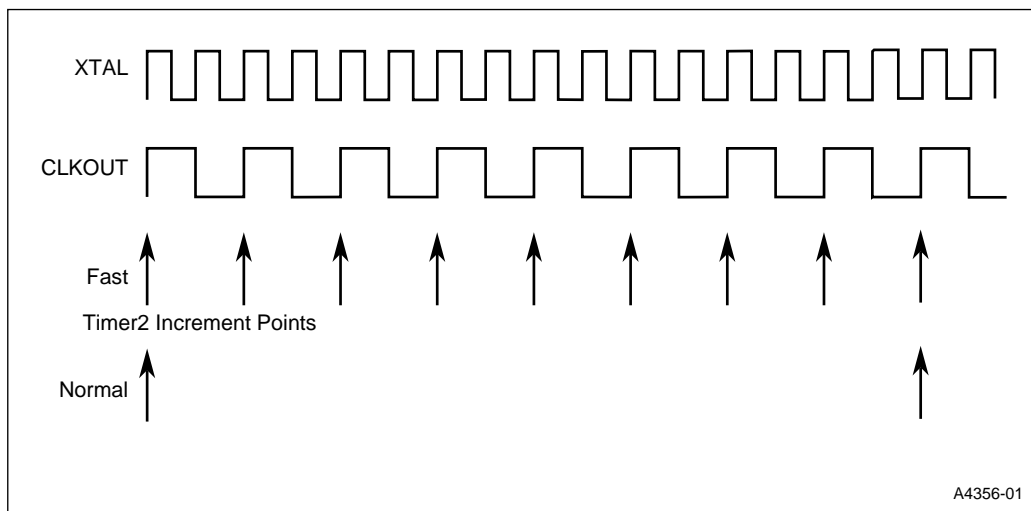
**PROBLEM:** Confusion has arisen regarding the fourth paragraph of Section 8.1.3.1. The following paragraph clarifies this text:

When FAST\_T2\_ENA is set (fast increment mode), Timer 2 increments once every state time, at the rate of  $F_{osc}/4$ . When FAST\_T2\_ENA is cleared (normal increment mode), Timer 2 increments once every eight state times at a rate of  $F_{osc}/32$ . See the timing diagram below for a depiction of the input clock signal, the clockout signal, and the points at which Timer 2 increments in the fast and normal modes.
