# **8XC196NT SPECIFICATION UPDATE**

Order Number 272865-002

The 8XC196NT may contain design defects or errors known as errata. Characterized errata that may cause the 8XC196NT's behavior to deviate from published specifications are documented in this specification update.

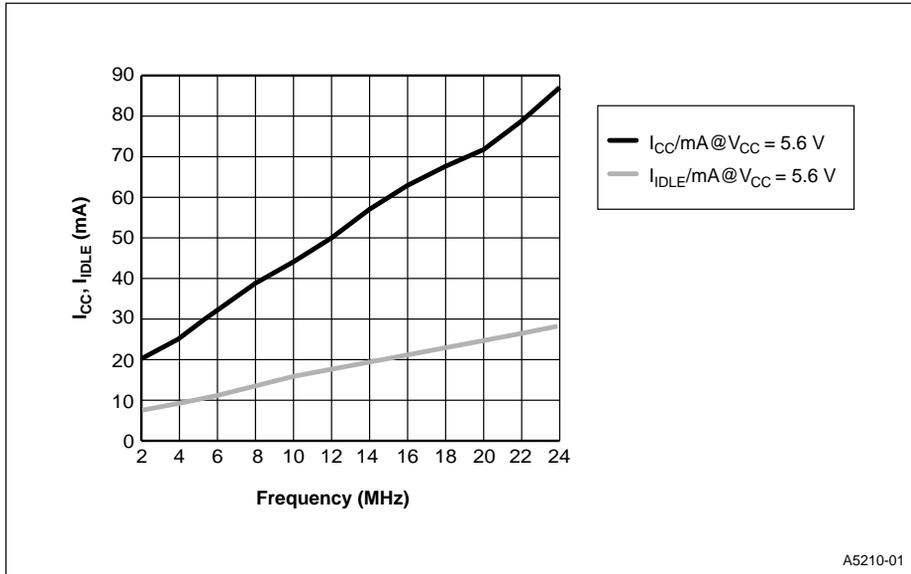
**ITEM:** The following graphic illustrating ICC and IDLE versus Frequency will be added to the next revision (-005) of the 8XC196NT CMOS Microcontroller datasheet.

Figure 1. ICC, IDLE versus Frequency

### 001. *ICC, IDLE versus Frequency*
